Volume 10: SUMMER 2008
IN THIS ISSUE . . .

Architectnics is the architectural technology journal of McGinnis Chen Associates, Inc.

A RECONSTRUCTION OF ELEVATED ENTRY WALKWAYS

A Case Study
by Majid Azadeh, PE

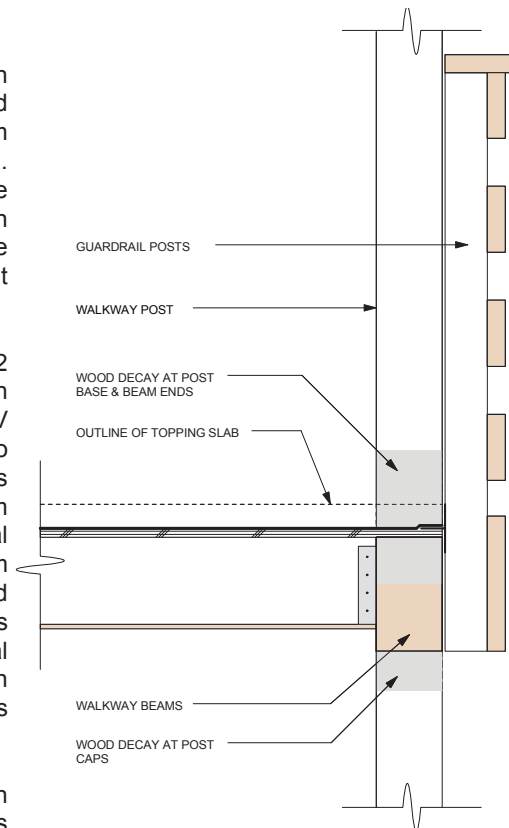
Original Elevated Walkway

The existing walkways and stairs were constructed of heavy timber post and beam framing of untreated Douglas Fir. End grains were exposed to weather at column tops and beam ends. Guardrail posts and railings were also fabricated from untreated Douglas Fir framing elements. All exposed framing elements were painted after construction with no application of primer at concealed joints.

The walkways were paved with a concrete topping slab cast over self-adhered sheet membrane applied directly over the plywood sub-floor. The existing membrane was punctuated by numerous post penetrations with inadequate and/or maintenance intensive flashing. Membrane delamination and waterproofing discontinuities were noted at nearly all penetrations and terminations. Lack of adequate drainage further exacerbated the overall distress to the structural elements.

Membrane flashing failures had occurred at nearly all post penetrations, resulting in severe deterioration of posts, beams and plywood sub-floors. Further deterioration of post bases had occurred at connections to podium slabs. Wood decay was also noted at the concealed joints between top rails and caps of the guardrails.
